TOWN OF LAKEVILLE PUBLIC SAFETY & TOWN OFFICES FEASIBILITY STUDY

LAKEVILLE, MA
MAY 21, 2007

Kaestle Boos Associates, Inc.
325 Foxborough Boulevard
Foxborough, MA 02035

PUBLIC SAFETY &
TOWN OFFICES
FEASIBILITY STUDY

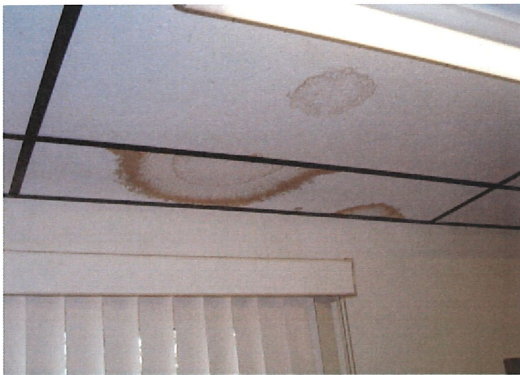
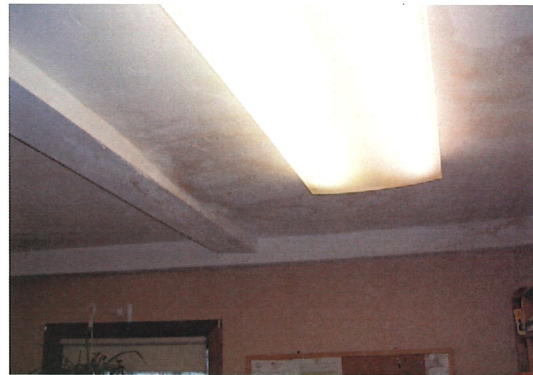
Roof leaks have caused visible damage within at least 2 interior locations. At the Records Office, the drywall ceiling has broken away from the ceiling framing due to water penetration. A hole has been drilled into the ceiling to allow the water to flow and mitigate further damage; however, the source problem still exists. Where the former COA space abuts the Police Station, water staining is noted in the Storage Room between the COA and the Police Station; in the adjacent Booking Room in the Police Station water damage has stained the walls and carpet. This is probably due to flashing issues where the existing and new roofs were connected during construction of the COA space.

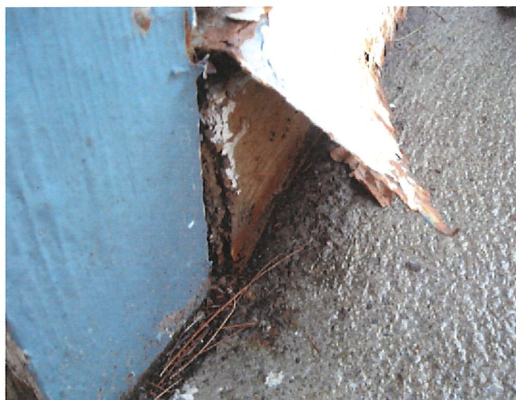
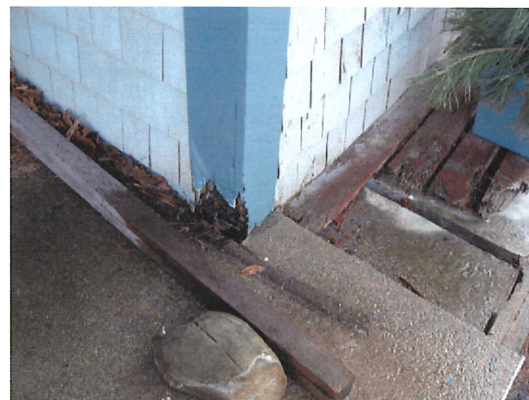
With each addition, different types of construction have created several different conditions between the foundation wall and the pavement. In many cases, a foundation wall does not exist because the floor is framed above grade on supports; in other cases, the foundation wall is low and the wood wall framing is down to grade. As observed, the base flashing in such cases is probably painted galvanized steel which has over time, due to exposure to abuse such as snow clearing, rusted through and become ragged at the edge. The standing water that caused the rusting of this flashing also can cause decay and rot of the wood framing, now exposed and unprotected, behind it. In other locations where the floor is framed out of wood and without foundation walls, boards have been used to close off the open space below the floor. These boards are loose and in some cases rotted, not only allowing cold air into the space below the floor but also providing an entrance for vermin. It was reported that vermin infestation has recently occurred at the Police Station.

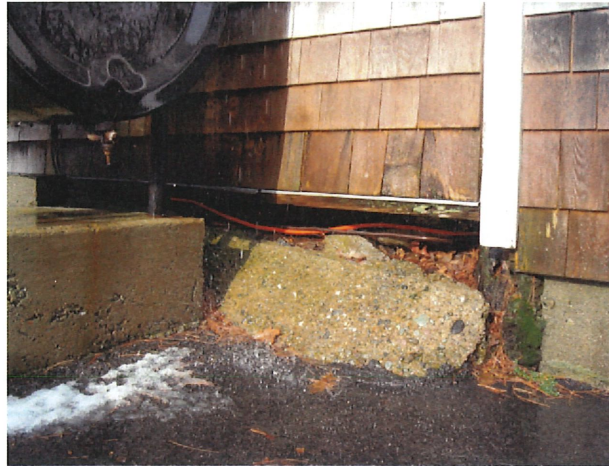
For example, at the south face of the building between the Records Office and the Office for the Chief of Police, there is no exterior foundation wall visible. Concrete appears to have been bermed up to close the space between the pavement to the underside of the floor framing. However, this has broken up over time exposing the underside of the floor framing to the weather. A wood post at the southeast corner of this framing was observed to be saturated with water with active fungi growth; pieces of this post could be broken away by hand.

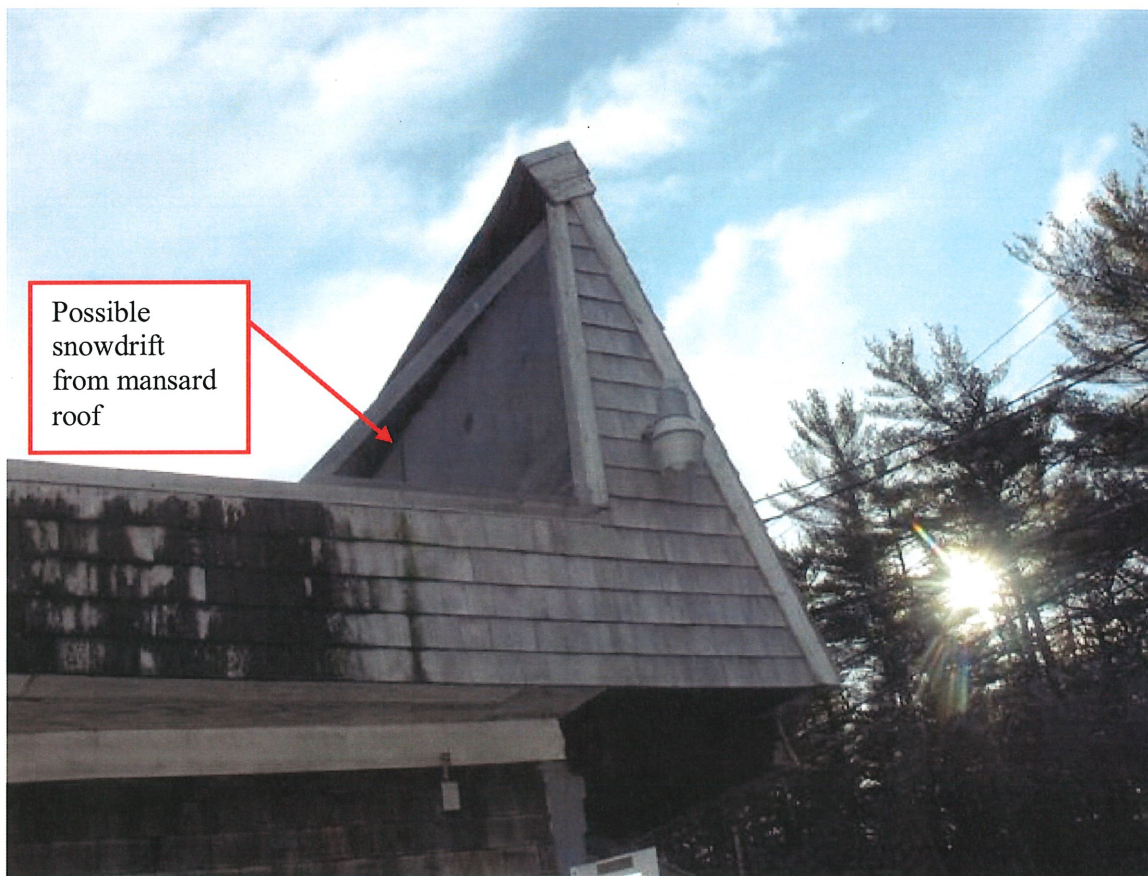
Two issues involve the roof framing for the original building and the additions. The height of the mansard roof along the front of the building appears to be imposing snowdrift loads on the actual roof framing beyond the wall.

Backside of mansard roof

The roof trusses and the roof framing along the front of the building must be evaluated for carrying the snowdrift load imposed by the mansard roof. All reinforcing or strengthening of the existing roof structure should be implemented before making any roof repairs. Joists must be added to either side of the notched joist noted above in the report.

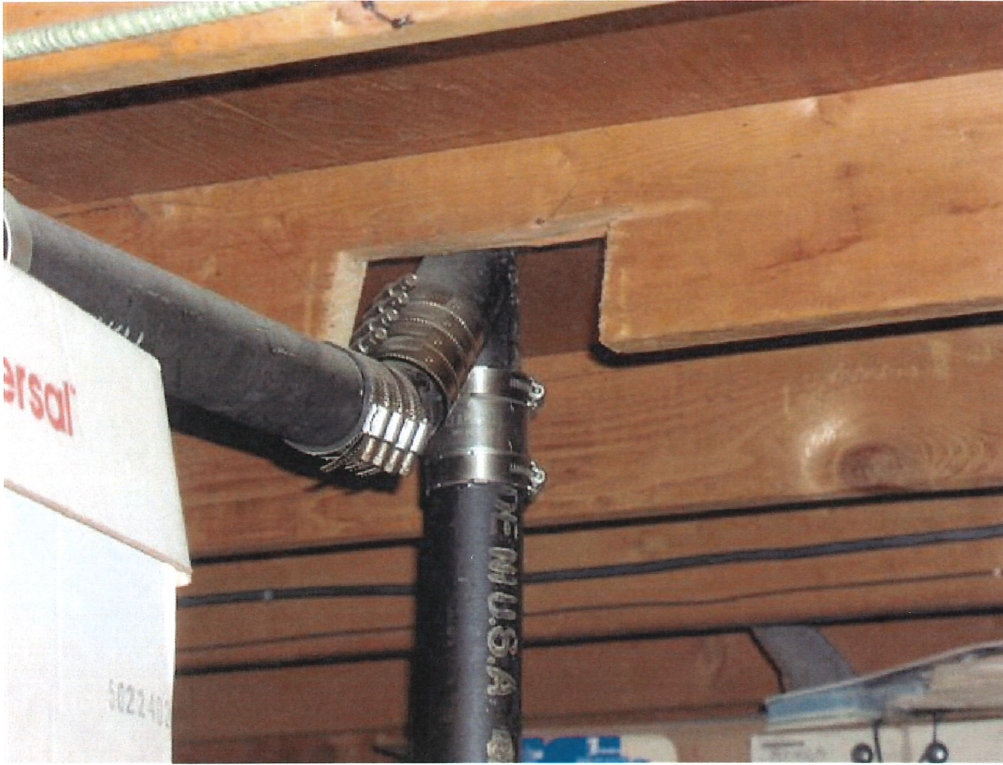
A portion of the framing, as noted above, was constructed with 2 x 6 joists at 2'-0" on center. The framing should be evaluated for the imposed snowdrifts. Above the locker room, one of the joists spanning from the exterior wall to the wall forming the Security / Dispatch Room was severely notched to install a stack vent. Additional framing or reinforcing of the notch was not provided.

Notched joist at vent stack

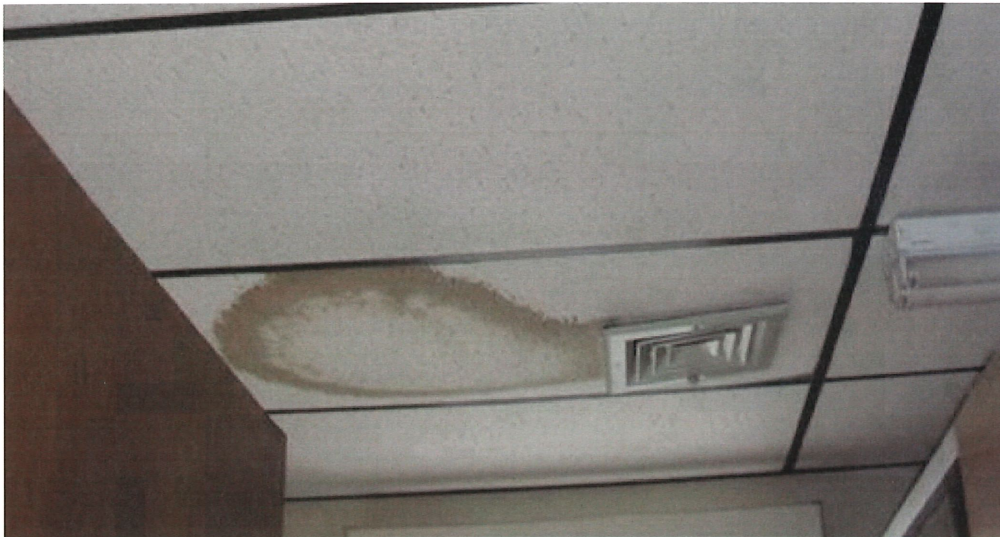
Water stains on the ceiling tiles in some locations within the building indicate that the roof is leaking.

Severely saturated ceiling tile at roof leak

The condition of the roof deck in the vicinity of the leaks must be checked for deterioration.

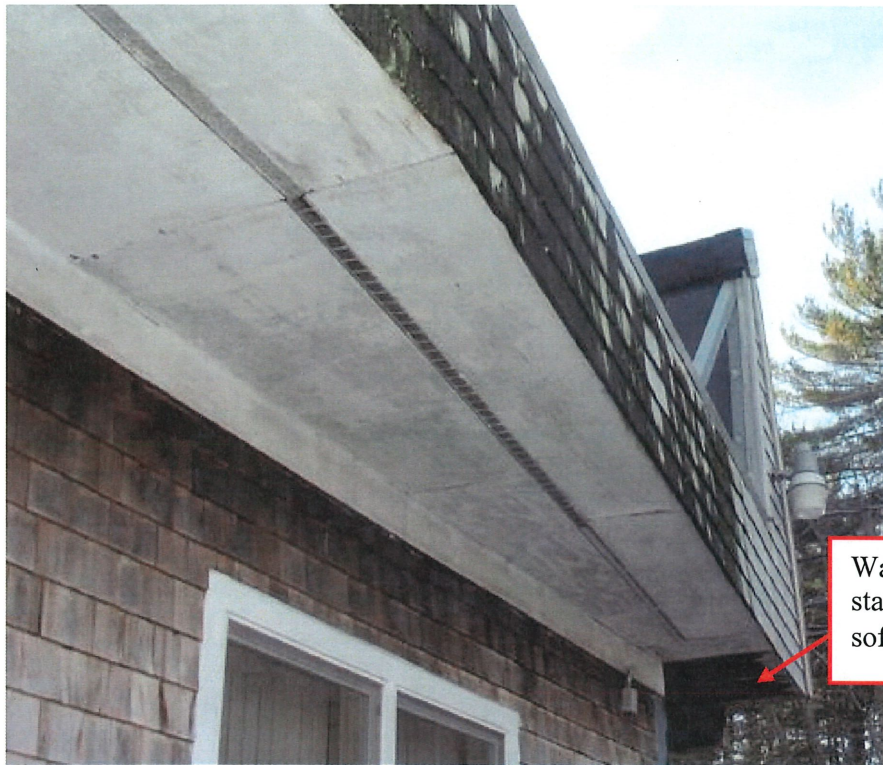
Water stains and wetness was visible on the underside of the exterior soffits at the mansard roof and the overhang on the north side of the building. Deteriorating wood soffits are present in some of the areas noted above.

Soffit on north side of building

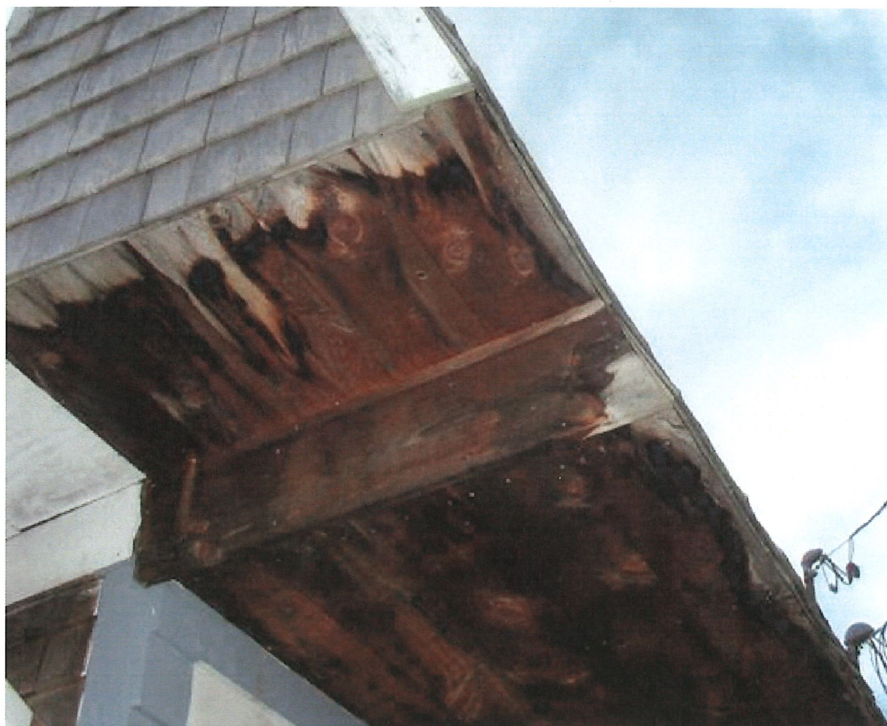
Water stained and deteriorated soffit at Mansard Roof

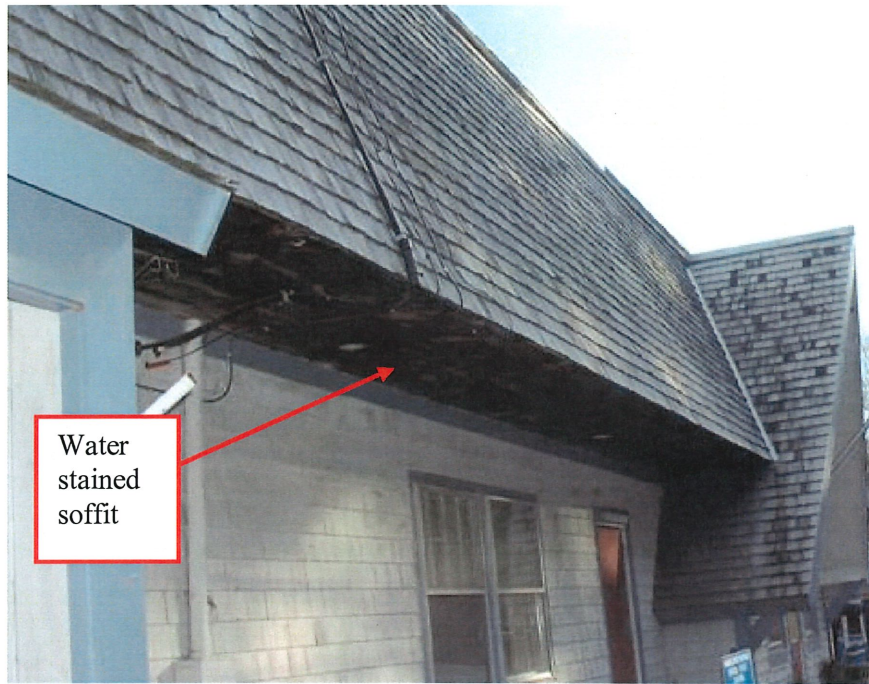
Water
stained
soffit

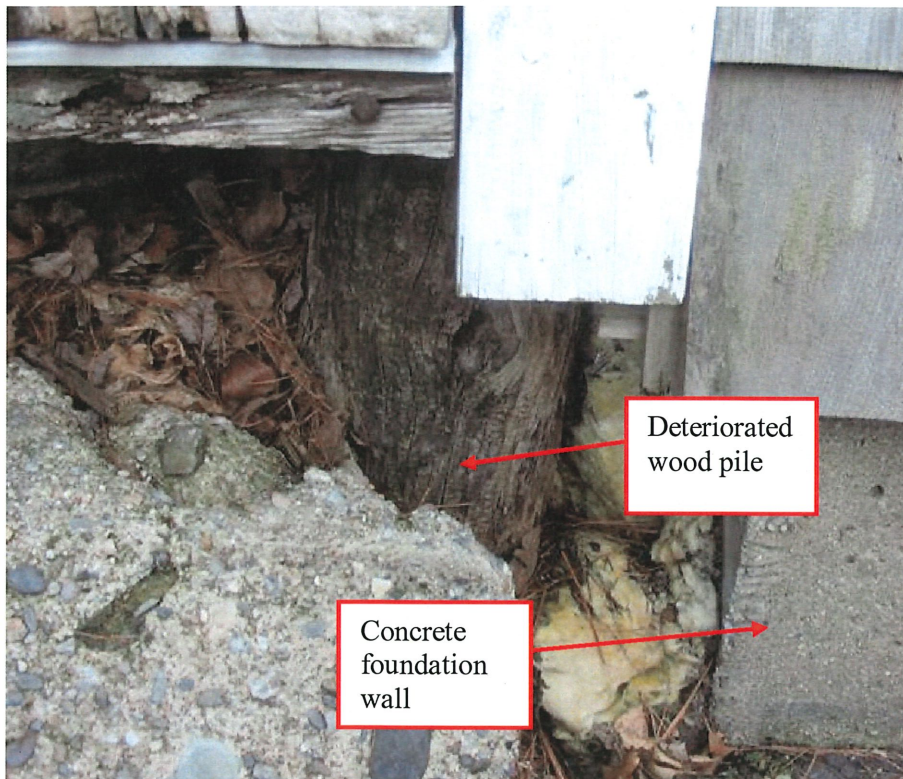
The exposed wood piles on the southwest corner of the original building adjacent to the police entrance are deteriorating due to exposure from the weather. The wood is exhibiting signs of dry rot and splitting. The floor and exterior wall framing bear on the piles. The other piles were not accessible but may have similar conditions.

Deteriorated
wood pile

Concrete
foundation
wall

Conditions at exposed wood piles

It is recommended that geotechnical borings be taken in the vicinity of the existing piles for the original building to address alternative solutions for re-supporting the structure without utilizing the existing piles. Recommended remedial work will be based on the Geotechnical Report findings.

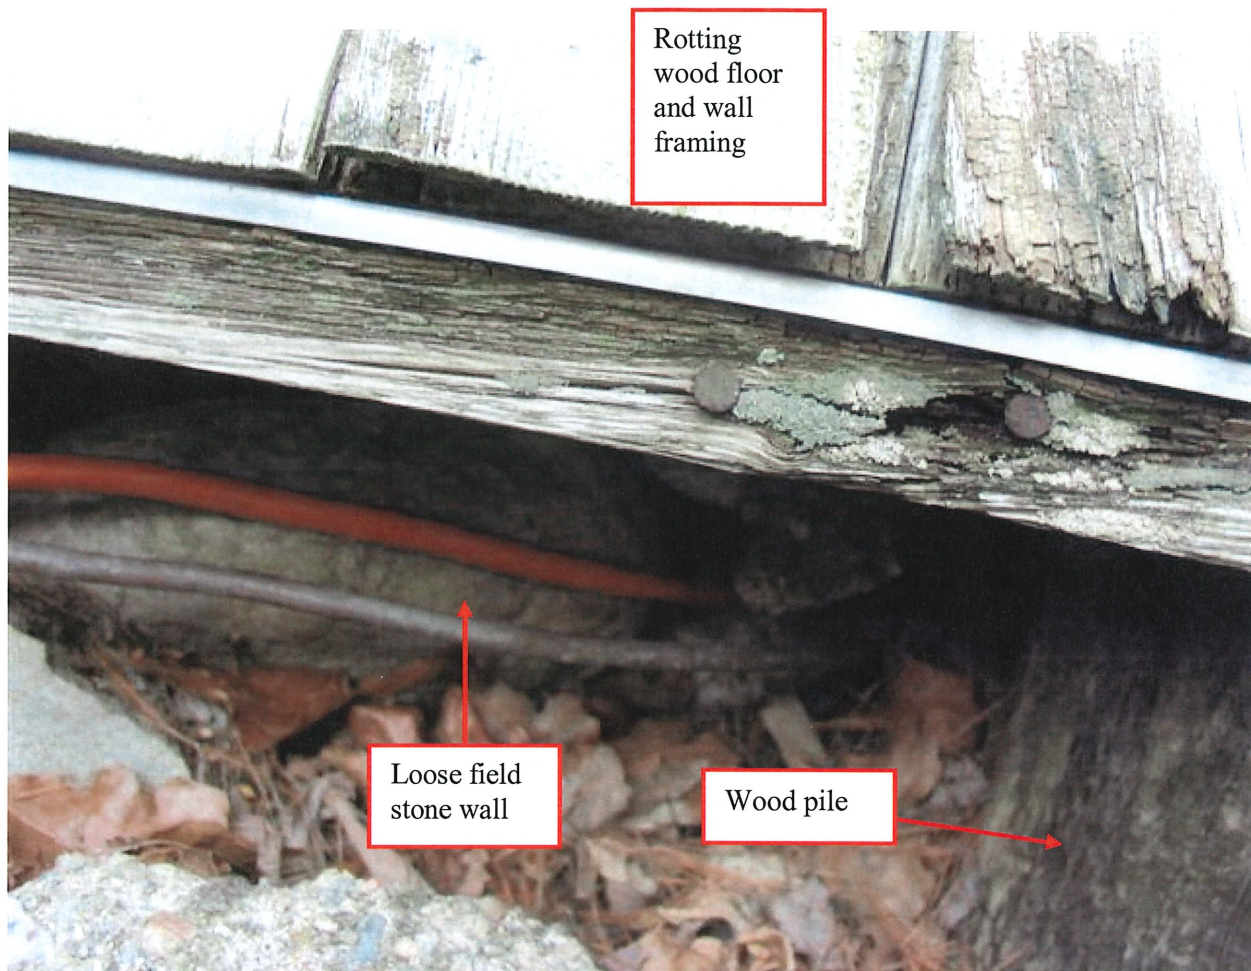
Condition at wood pile foundation on south side of building

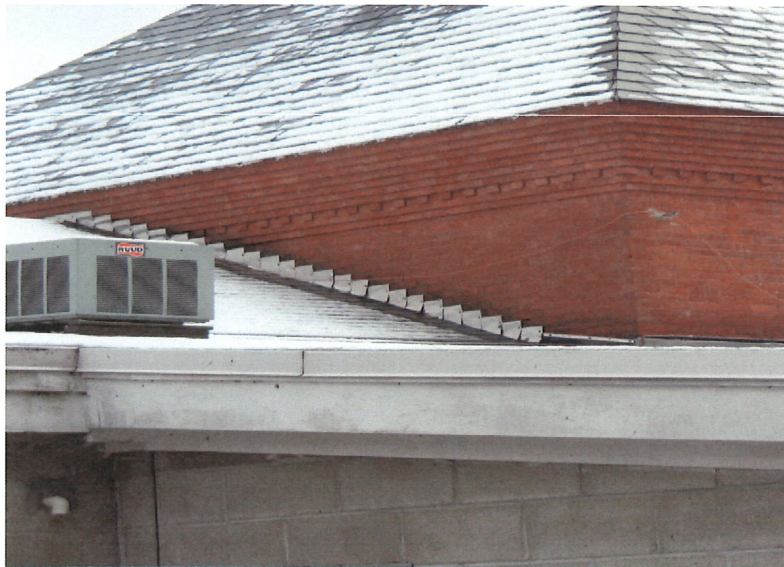
At the connection between the original Pump House exterior wall and the first apparatus bay addition, the step flashing at the roofline of the addition to the existing brick wall has gaps and is poorly fit allowing penetration of moisture and insects. This flashing stops at a termination bar installed at the connection for the EPDM membrane roofing for a later Fire Department addition. This termination bar is not flashed up and into the existing brick wall; snow accumulation and deterioration of sealant at this connection may lead to water penetration.

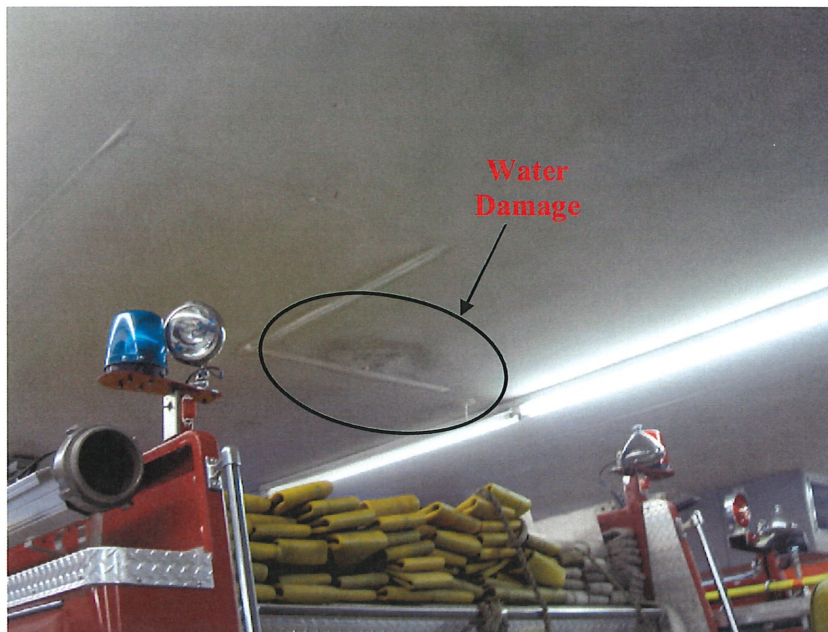
Water penetration has caused visible damage in several interior locations. On the Second Floor of the southern (upper) portion of the Town Offices, stained ceiling tiles are visible in the Accounting Office. Similarly, stained tiles were observed on the Second Floor of the northern (lower) portion of the Town Offices in the open office area. Drips from apparent water staining are visible along the arched masonry at the original Pump House entrance vestibule. In the Fire Station Apparatus Bay, a joint in the drywall ceiling is failing and stained from moisture or water penetration. Wood window sills also show signs of deterioration at locations on the Second Floor where original single pane steel frame windows are still in place.

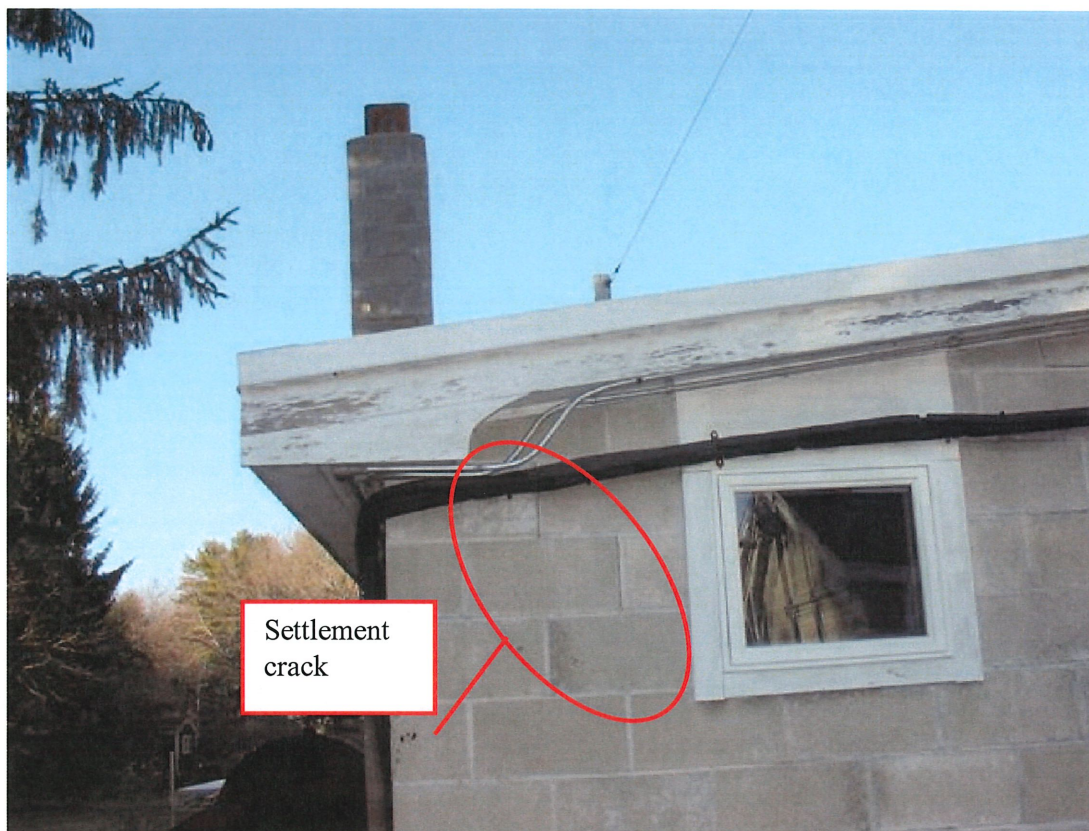
There are issues with the masonry bearing walls of the additions. Settlement or movement was observed in the exposed face of the exterior concrete block bearing walls on the west and south west sides of the pre-1993 additions. Some of the cracks are visible around window and door openings. It is not known if the movement is continuing to occur. Water is entering through the cracks and freeze / thaw damage will aggravate the condition. The foundations in these areas are concealed beneath grade and could not be reviewed for deterioration without excavation.

South face of addition

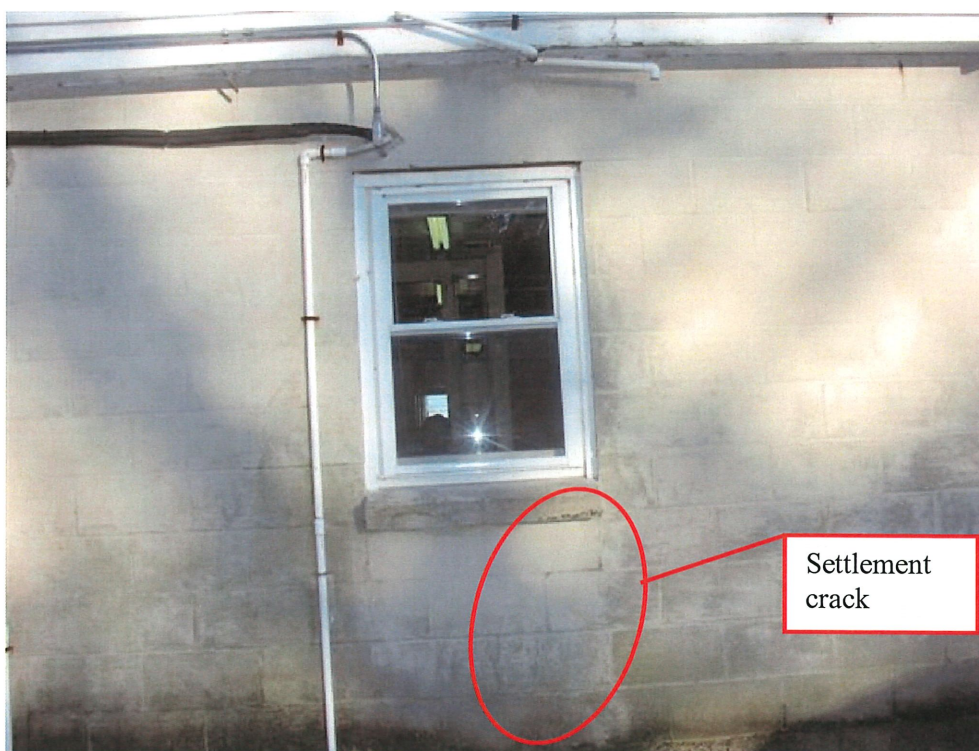
West face of addition

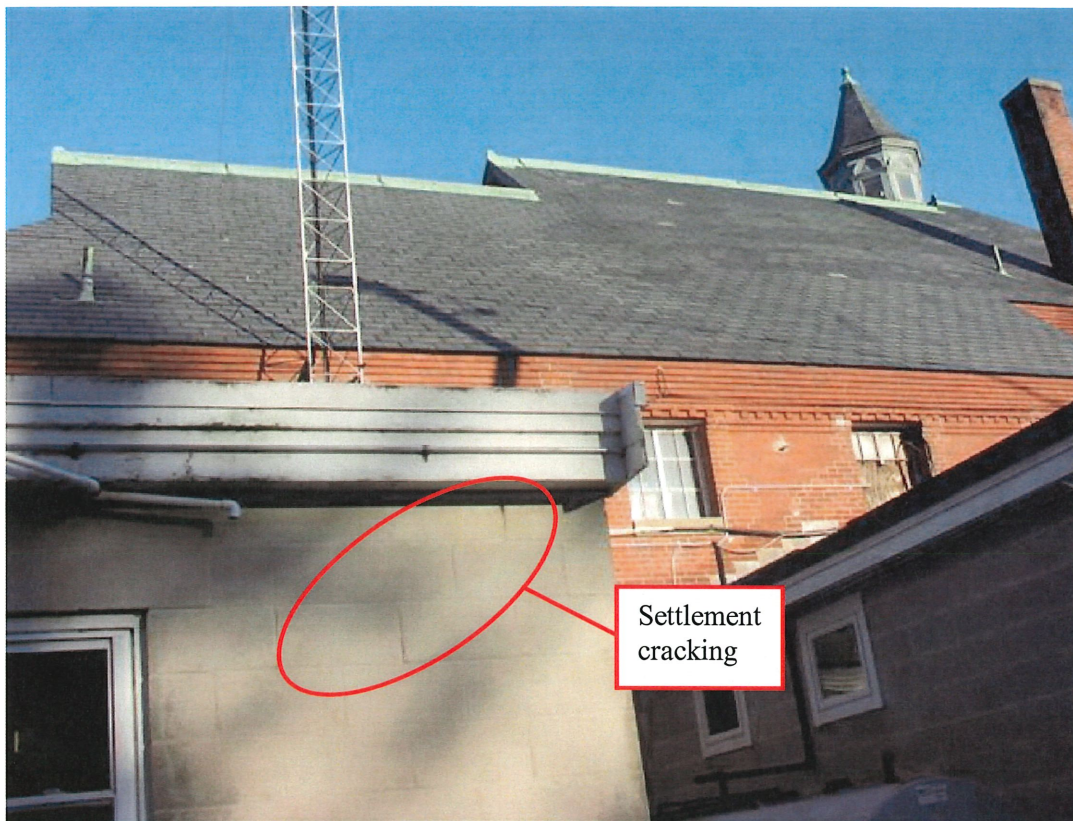
Settlement
cracking

Cracking and movement at the southwest corner of the addition

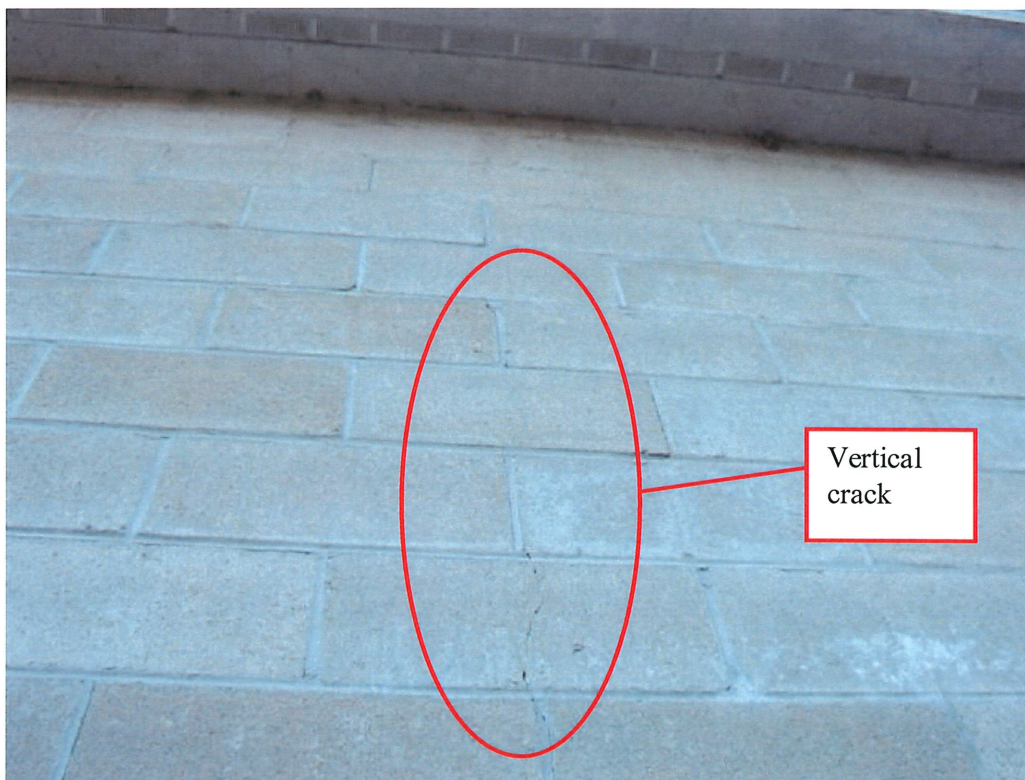
Vertical
crack

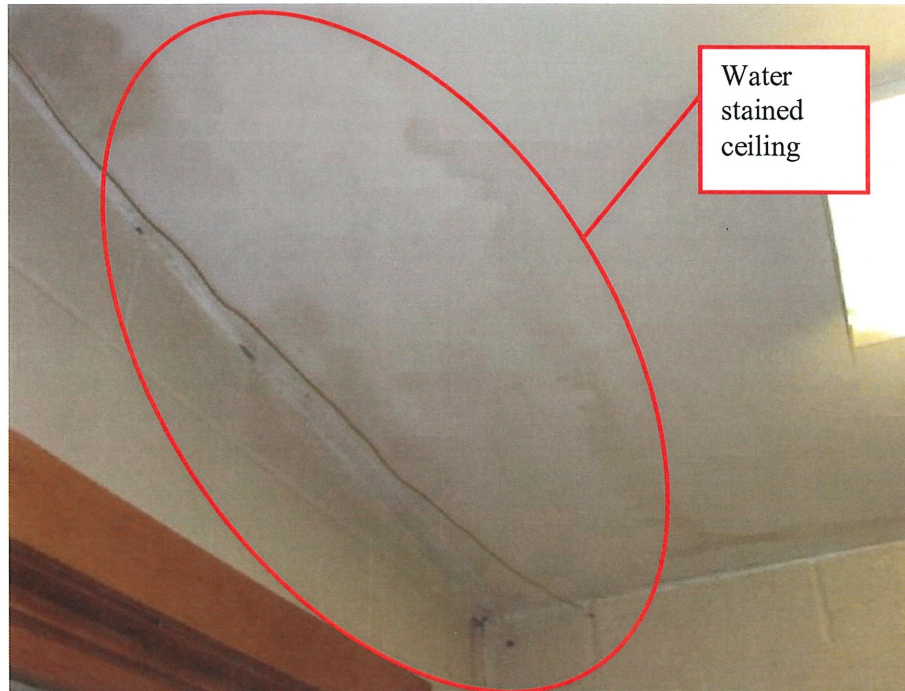
Water stains on the ceiling tiles in some locations within the building indicate that the roof has leaked. The roof sheathing in these areas is not visible without selective demolition of the drywall/plaster ceilings.

Water
stained
ceiling

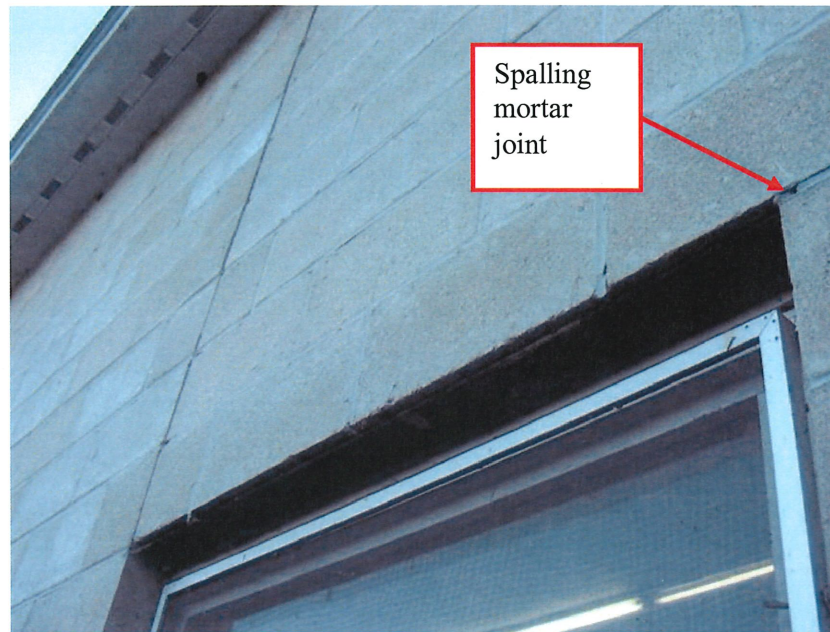
The exposed steel angle lintels which support the exterior concrete block walls above the window openings do not appear to be galvanized. The mortar joints where the lintels bear have begun to spall which will allow water to enter into the joint. The freeze / thaw action, due to water infiltration, will increase the amount of spalling to the mortar and the concrete block wall. The lintels for the windows in the original building appear to be painted and maintained to minimize water infiltration.

Lintel condition at the 1993 addition
