PRESENTATION BY SOCOTEC ON THE TOWN HALL/FIRE STATION FEASIBILITY STUDY

Town Hall & Fire Station Study 346 Bedford St Lakeville, Massachusetts September 2, 2022

Lakeville Town Hall & Fire Station Study

Facilities Review and Space Needs Assessment

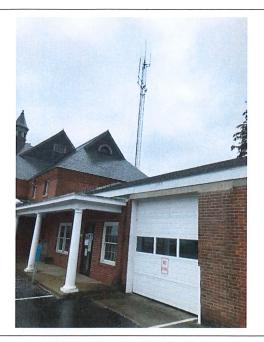
Radio tower with guy wires attached to the building at various points and causing damage in some locations.
