TOWN OF LAKEVILLE PUBLIC SAFETY & TOWN OFFICES FEASIBILITY STUDY

LAKEVILLE, MA
MAY 21, 2007

Kaestle Boos Associates, Inc.
325 Foxborough Boulevard
Foxborough, MA 02035

PUBLIC SAFETY &
TOWN OFFICES
FEASIBILITY STUDY

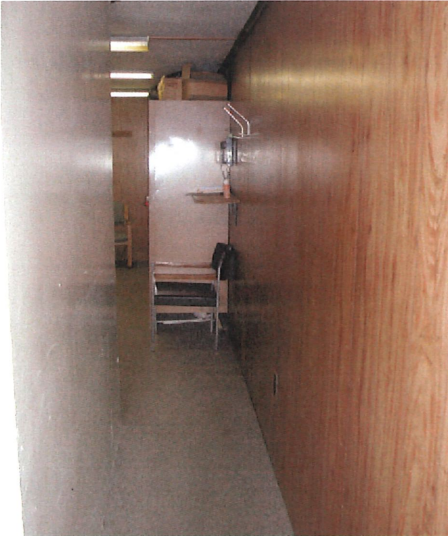
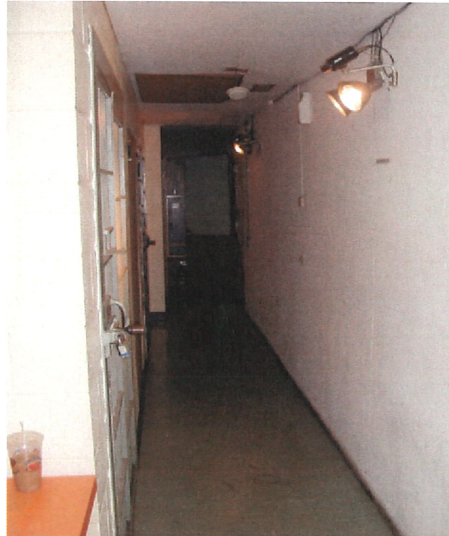
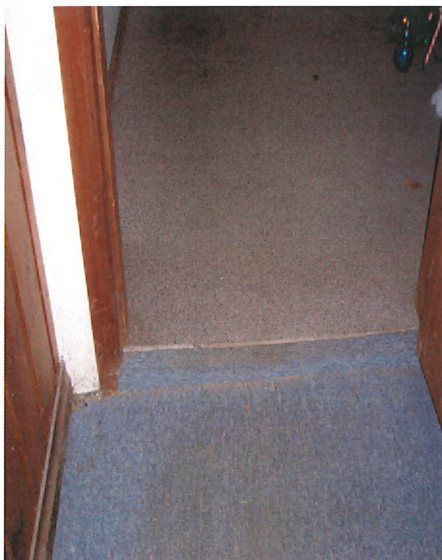
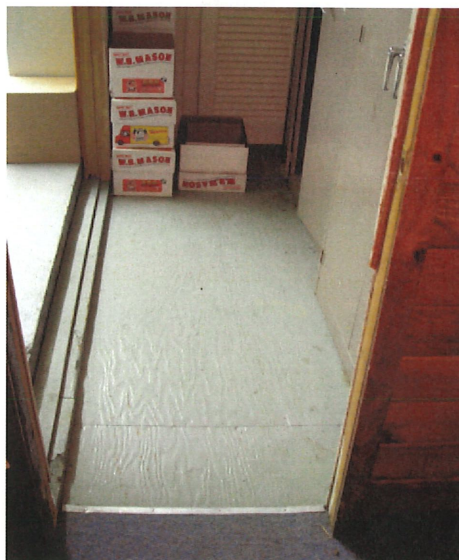
Egress issues have developed over time because of the several additions and renovations that the building has undergone. Issues begin in the Entrance Lobby/Waiting Area, where not only are the doors inaccessible according to AAB, but door heights are below the 6'-8" minimum height required for egress doors. Other doors in corridors in the building are also lower than permitted, some were found to be as low as 6'-4" above finish floor. Within the cell area, the cell doors are narrower (23.5" clear) than permitted (28" minimum clearance); these cell doors also swing outward into the narrow corridor, which is narrower than the minimum allowed, and so may impede passage through the corridor even when the doors are fully open. In addition, ceiling heights in egress corridors in some locations between the original building and additions are lower than the 6'-8" minimum height permitted; for example, the ceiling in the rear corridor is as low as 6'-5" above finish floor. Egress from the men's locker room is constricted as the corridor leading to it is only 27" wide, far narrower than the 44" minimum clear width permitted and inaccessible to handicapped or temporarily disabled employees. Finally, because of differential elevations of floor framing, small steps occur within egress corridors throughout the building including a small 3" step at the Entrance Lobby, creating tripping hazards. In combination, all these conditions create a hazardous egress path from this building.

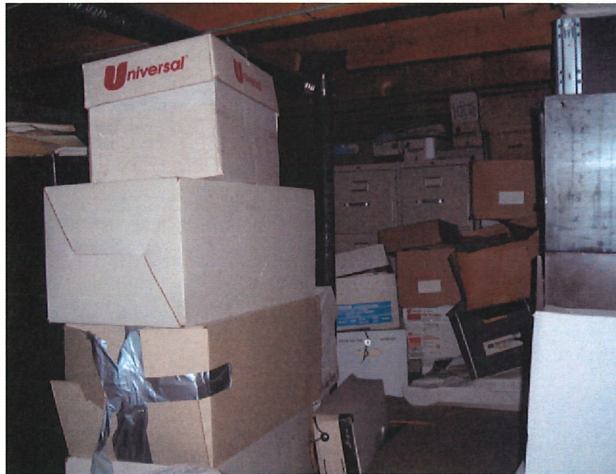
While accessory occupancies are allowed within the Business use, some occupancies are still required to be separated by fire-rated construction because of the greater hazard that they create. Storage areas, depending on size, must be separated by fire-rated construction or sprinklers with smoke-rated partitions. No storage areas in the existing building are separated in accordance with these requirements. Also, because of the shortage of space for the department's storage and file needs, other unprotected areas are now used for storage, creating a greater hazard. One of these areas is above the ceiling in the attic space over the cell and locker areas. In combination with the egress issues noted above and with the possibility of a fire event beginning unnoticed in the concealed, combustible attic storage space, the occupants in these areas are at greater risk in the event of a fire.

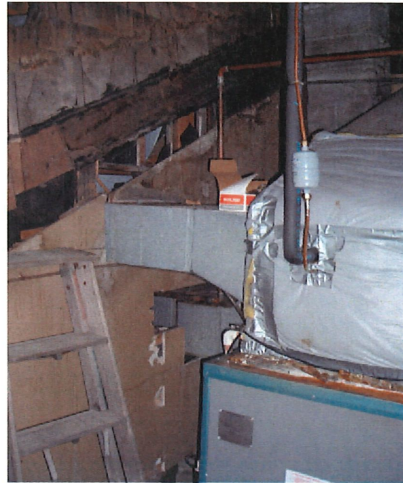
Another occupancy that is required to be separated is an area that is used for boilers. Of the two mechanical spaces in the building, one is accessible only from the exterior and one is landlocked in the center of the rear office addition adjacent to the Chief of Police. Both boilers are oil-fired. The mechanical room in the office addition is within an unrated combustible space which is accessed through unrated doors. Wood framing and insulation in the new addition as well as the existing shingles of the former exterior wall are exposed within the room in violation of Code requirements. Boiler rooms must be separated from

adjacent spaces with a one hour fire-rated partition or be protected by sprinklers; these boiler rooms, as described above, do not comply with either of these requirements.

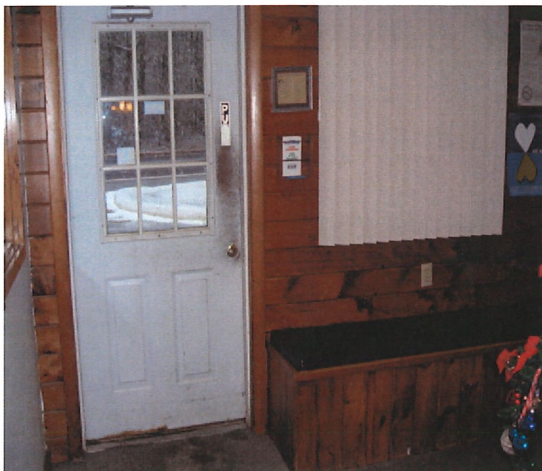
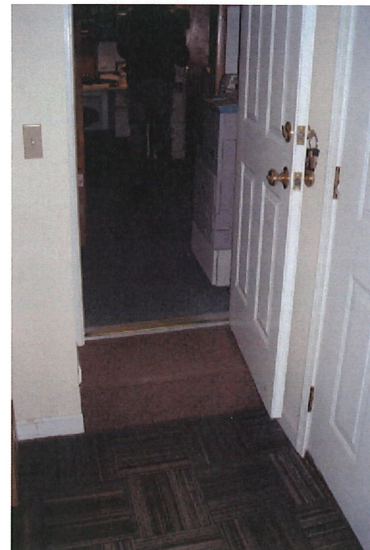
The steps noted above in rooms and corridors which create tripping hazards for ambulatory persons also limit accessibility for handicapped persons. For example, a civilian receptionist, secretary, or clerk would not be able to move about in the building and emergency egress from the building for a handicapped person is very limited. This is obvious immediately at the entrance to the building, both at the main lobby and the entrance to the Training room. Both doors have asphalt berm ramps which have slopes greater than 1:20; because these are too steep to be considered "walks", they must provide railings and the required clearances for accessible ramps. At the main entrance and lobby, the entrance doors are not arranged to provide the required clearances so that a handicapped person can enter the building. Access to the training room from the police station is via a newly installed door which does not provide the clearances necessary to be operated by a handicapped person and includes an inaccessible step. Further, access to rooms is limited because door *knobs* are used instead of leversets.

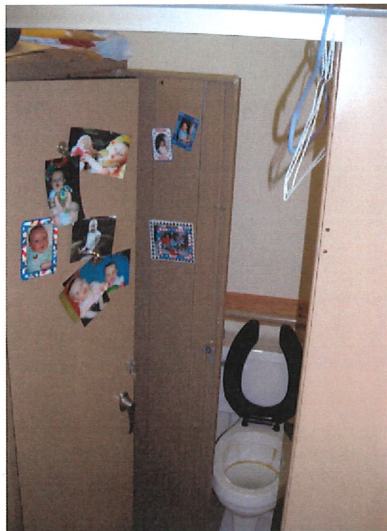
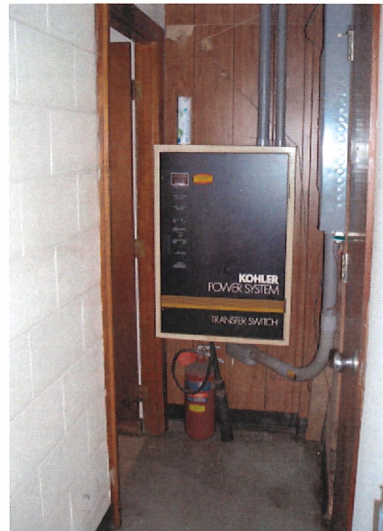
There is only one accessible toilet in the entire building located in the Men's bathroom at the rear of the former COA space. This space is not even accessible from the Police Station, as stated above, unless the person was to exit the Police Station and re-enter the building on the COA side. All other toilet rooms are too small, do not have accessible doors, do not provide required clearances for turning, or do not provide accessible fixtures. The Women's bathroom, adjacent to the Men's bathroom at the rear of the former COA space, is not accessible because the handicapped accessible toilet stall has been filled with lockers, turning it into a women's locker room. An accessible toilet has been provided adjacent to the holding cells. Apparently renovated from an existing vestibule, an exterior door remains part of the bathroom which is fitted with handicapped accessible fixtures, grab bars, mirrors and door hardware. This bathroom is inaccessible because the corridor entrance to the bathroom is blocked by a wall mounted electric panel and the emergency generator control panel which reduces the clear width at the door to less than 24", far too narrow for wheelchair access. Of the 6 toilet fixtures provided in the building - three are for men, two are for women and one is unisex - only 1 fixture is handicapped accessible and no accessible fixtures are provided for women.

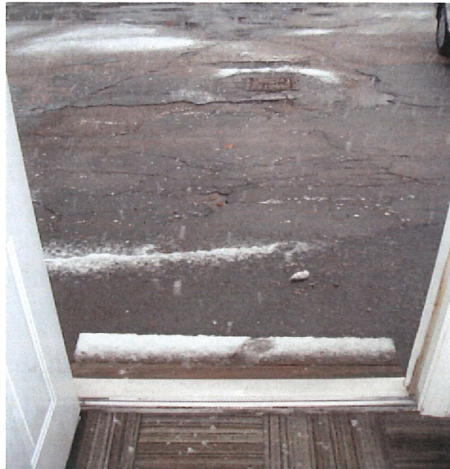
Neither of the two prisoner cells meets the requirements for handicap accessibility. The cells are not deep enough to provide for a 5 foot turning radius, as is required, within the cell for a wheelchair. Also, the toilet fixture is not located as is required for handicapped use. The cell doors are not wide enough to provide handicapped access to the cell and the corridor leading to the cells does not provide the required turn to access or, more importantly, egress the cells in an emergency. A handicapped prisoner would have difficulty entering the building because the Sallyport is not weather protected and the entrance from the Sallyport parking area has an inaccessible threshold. Requirements to safely detain and process a handicapped prisoner must be considered as a necessity in any renovation.

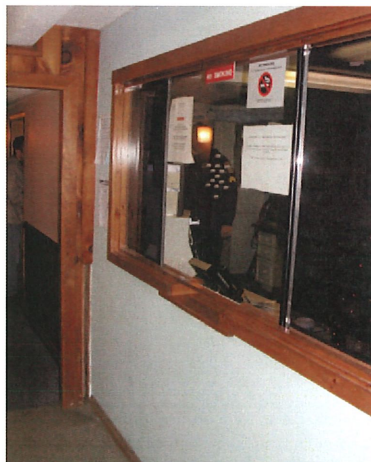
NFPA 1221 recommends that the dispatch/emergency communications center be protected with 2 hour fire-rated partitions and that the doors to this room or rooms should be fire-rated also. The public interface at the reception desk and lobby should be constructed to be bullet resistant. Although bullet resistant glass at the reception desk is provided, the openings in this glass may not restrict penetration by a gun or other weapon and the walls and doors surrounding the public lobby are standard construction and not bullet resistant. Also, the dispatch area is not separated from the Police Station with secure doors and rated partitions to protect the room and allow it to continue operation in an emergency situation. The recommendations stated in NFPA 1221 are intended to provide Emergency Control Centers with the optimum ability to perform in emergency situations. While doing this, these recommendations also provide guidelines for safe functioning of these centers throughout everyday operations.

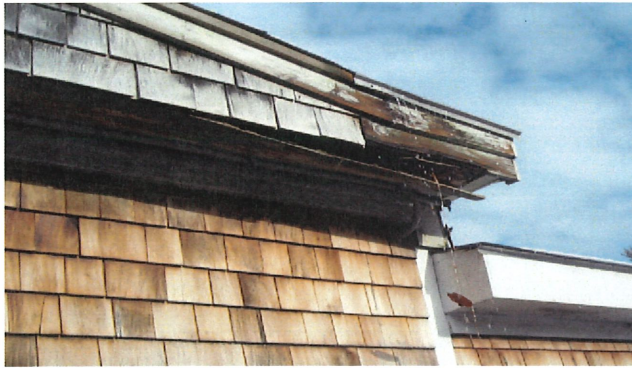
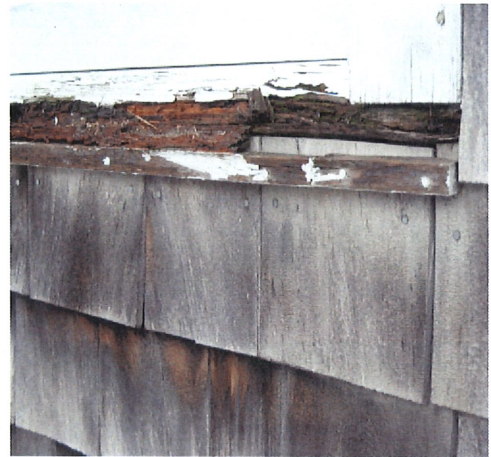
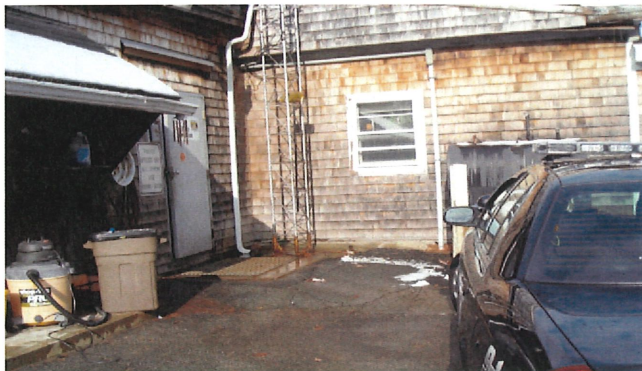
Water is dispersed from the roof to the pavement below, generally without the use of gutters and downspouts to direct the water flow. In several locations, the saturation of the wood shingles and trim has led to the growth of mold and fungi on the face of the building. Painted trim boards at the rakes and eaves have visible rot and decay from water dripping off and running down the face of the building. At one location, the soffit board has separated from the roof eave framing, due to rot, and is hanging loosely. Window sills are rotted and can be broken away by hand due to rot and decay. At the Sallyport parking area, a gutter and downspout have been added to direct water away from the cell area entrance door below, however, this has created a problem. As the water exits the downspout, it crosses the pavement in front of the Sallyport door creating a dangerous icing condition in the colder months. Also, this water passes directly across the base supports for the communications tower rusting the connecting bolts and support steel.

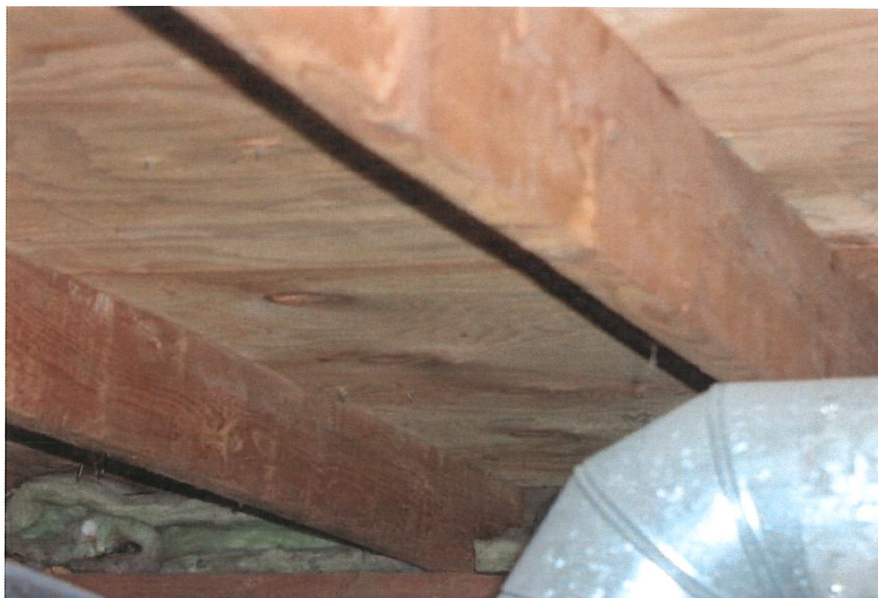
2 x 6 wood roof joists at 2'-0"

A portion of the framing, as noted above, was constructed with 2 x 6 joists at 2'-0" on center. The framing should be evaluated for the imposed snowdrifts. Above the locker room, one of the joists spanning from the exterior wall to the wall forming the Security / Dispatch Room was severely notched to install a stack vent. Additional framing or reinforcing of the notch was not provided.

The roof trusses and the roof framing along the front of the building must be evaluated for carrying the snowdrift load imposed by the mansard roof. All reinforcing or strengthening of the existing roof structure should be implemented before making any roof repairs. Joists must be added to either side of the notched joist noted above in the report.

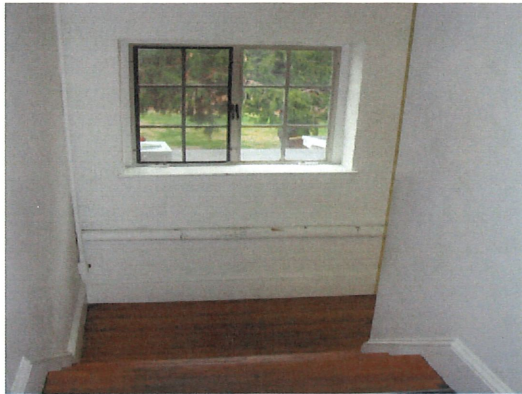
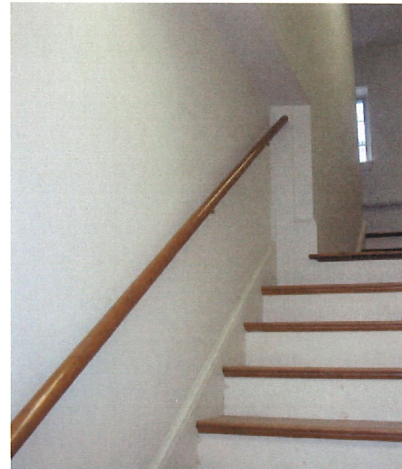
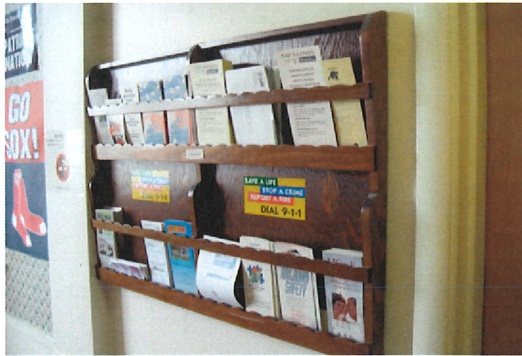
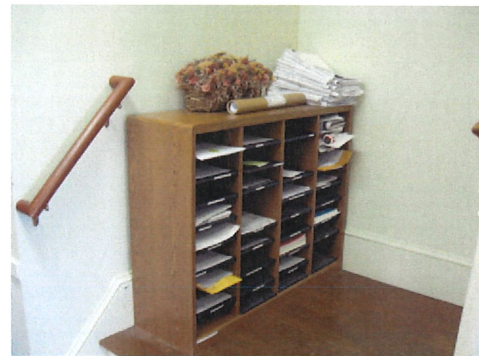
There are two stairs used for egress from the Second Floor of the Town Offices: one in the original Pump House in the southern half of the building and one in the addition to the north. Neither of these stairs is enclosed in a two hour fire rated enclosure, as required by current Code, and are open to the general office spaces within the building. Paper and other combustibles for mailboxes and pamphlets are exposed within the stairs and the exitway corridors connecting these stairs to the exterior. Handrails are made of combustible wood and are not continuous; guards at open stairs are not of the appropriate height as required by Code. Also, these stairs are constructed of wood, a combustible material, which compounds the egress problems from the Second Floor. As the building is currently not sprinklered, these unprotected egress paths from the Second Floor present a life safety hazard.

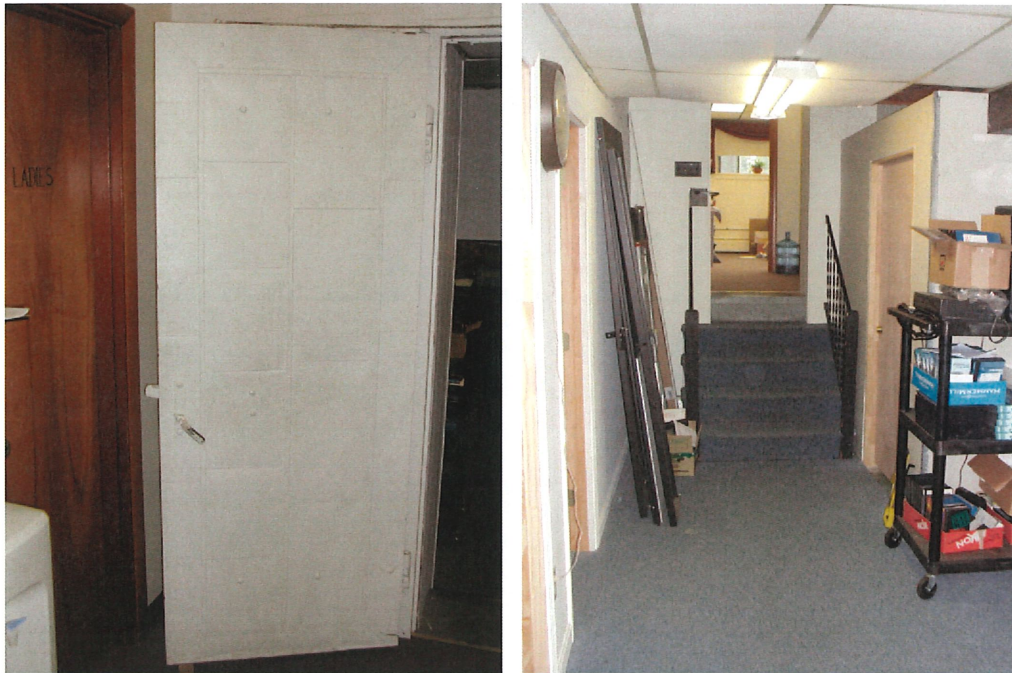
During renovations for the Fire Department and Town Offices, corridors were created with dead ends. By definition, dead end corridors are created when exitway corridors are more than 20 feet long but do not provide access to an exit at both ends. These

dead end corridors occur at the First Floor elevation of both egress stairs providing access to office space and the Fire Department. On the north side of the building, the corridor leading to the stair up to the Second Floor and to the Treasurer's Office is well beyond the second means of egress via the basement stair connection. On the south side of the building, the corridor leading to the stair up to the Second Floor and to the Fire Department door and the conference room is in the opposite direction to the exit to the exterior. In an emergency situation, especially with limited visibility or panic, persons may follow the corridor in the wrong direction. Doors and partitions, or accepted signage and gates, must be provided to direct egress traffic to exits.

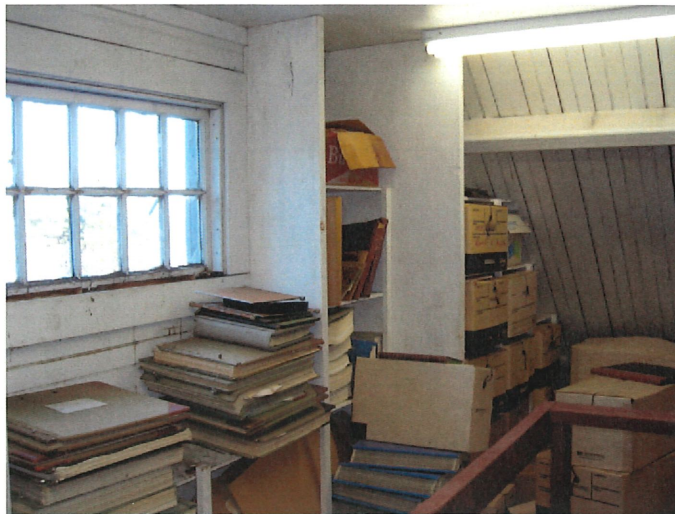
The two storage floor areas above the ceiling of the second floor office space, which are constructed of combustible wood frame materials, are not currently protected by fire-rated construction or sprinklered. As storage space in the basement of the building is moved elsewhere because of water and moisture issues, the shortage of space for storage and file needs will result in other unprotected areas to be used for storage creating a greater hazard for egress.

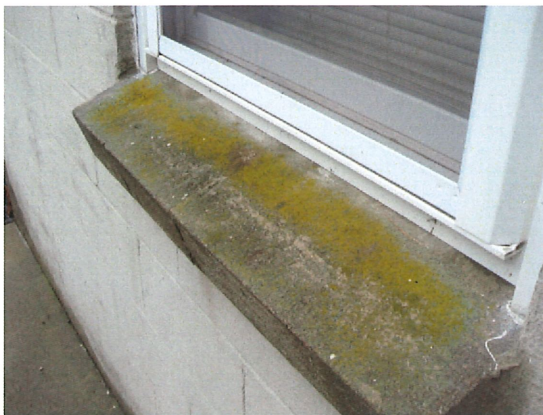
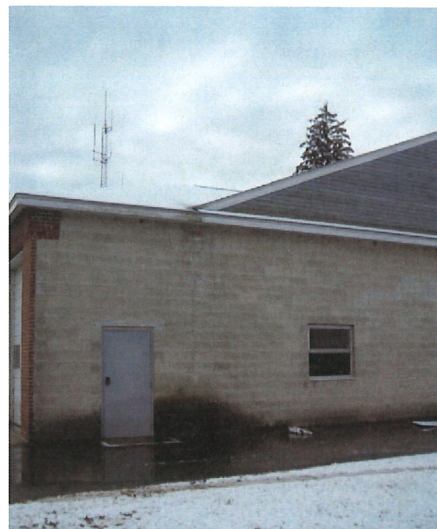
However, the flow of water around the building from the roof to the ground is problematic in some areas and has caused some non-structural damage. Water is dispersed from the roof to the pavement below, generally without the use of gutters and downspouts to direct the water flow. In several locations, the saturation of the exterior masonry has led to the growth of mold and fungi on the face of the building. Painted trim boards at the rakes and eaves have visible rot and decay from water dripping off and running down the face of the building. As the water exits the downspouts without a perimeter runoff collection system, it crosses the pavement creating dangerous icing conditions, especially at egress doors, in the colder months.

This uncontrolled runoff has also eroded soil at grade in unpaved areas, such as at the rear access door to the Apparatus Bay, creating a hazard for egress and making vehicular access difficult.

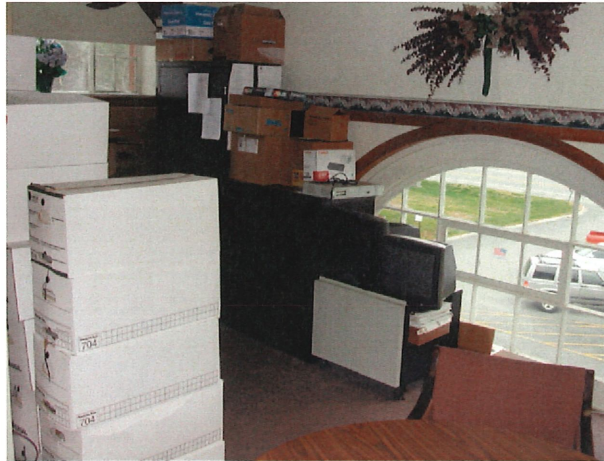
File storage, as noted above, is dispersed throughout the facility, in some cases in people's homes, and is improperly placed in the upper levels of the original Pump House. Widely dispersed files and lack of proper archival filing space has forced makeshift file storage in attic spaces and wherever open areas can be found. Ideally, the central archival file storage area would be provided to allow for orderly storage of outdated files that must be maintained by law and not be distributed throughout the building. Not only does dense filing creates structural loading issues on upper floors supported with wood framing, but also creates clutter and affects the efficiency of the offices.

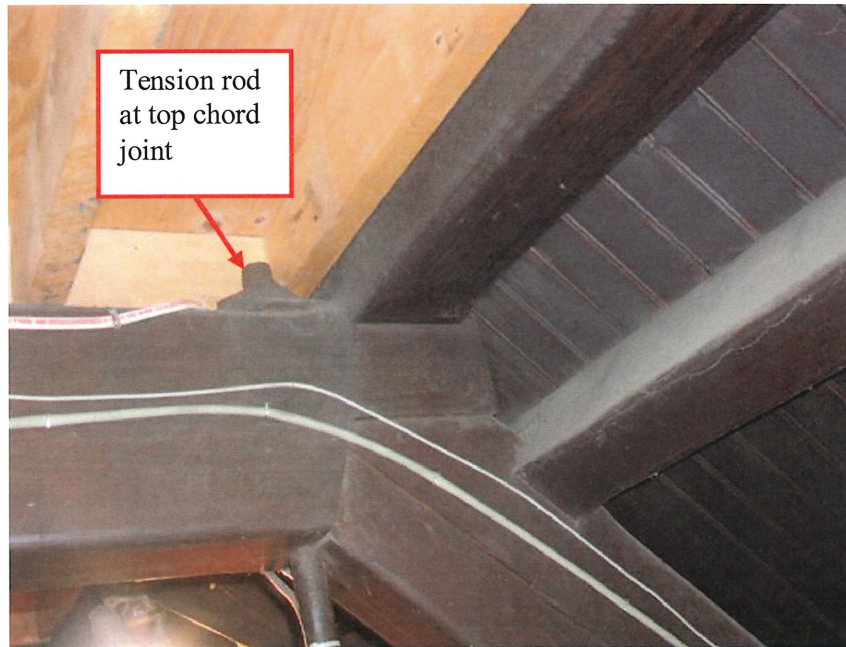
Timber roof truss connection detail

The original building, based upon our observation of the exposed structure is sound. The exterior masonry walls are not exhibiting movement or spalling. The wood roof framing, as viewed from the attic space, appeared to be undisturbed without signs of deterioration as viewed from below.

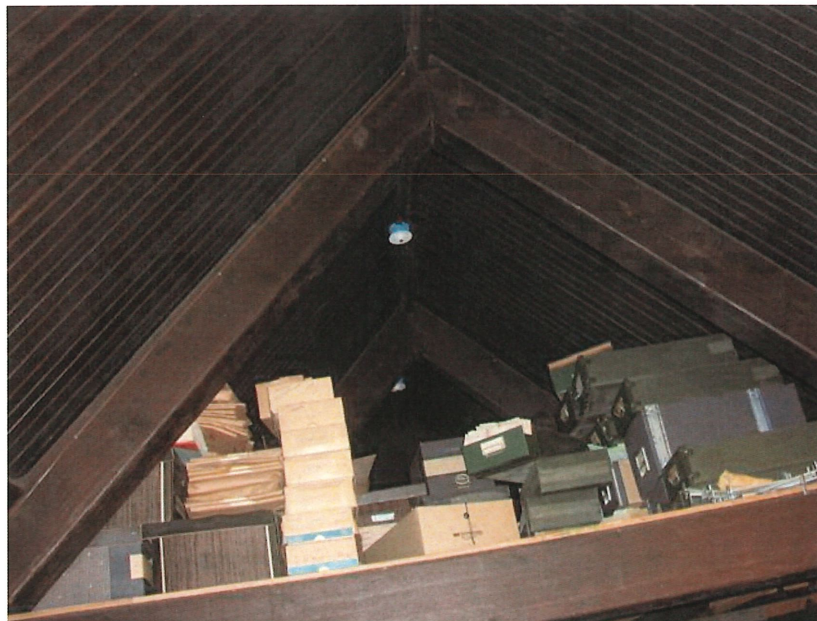
Timber roof truss supporting loft

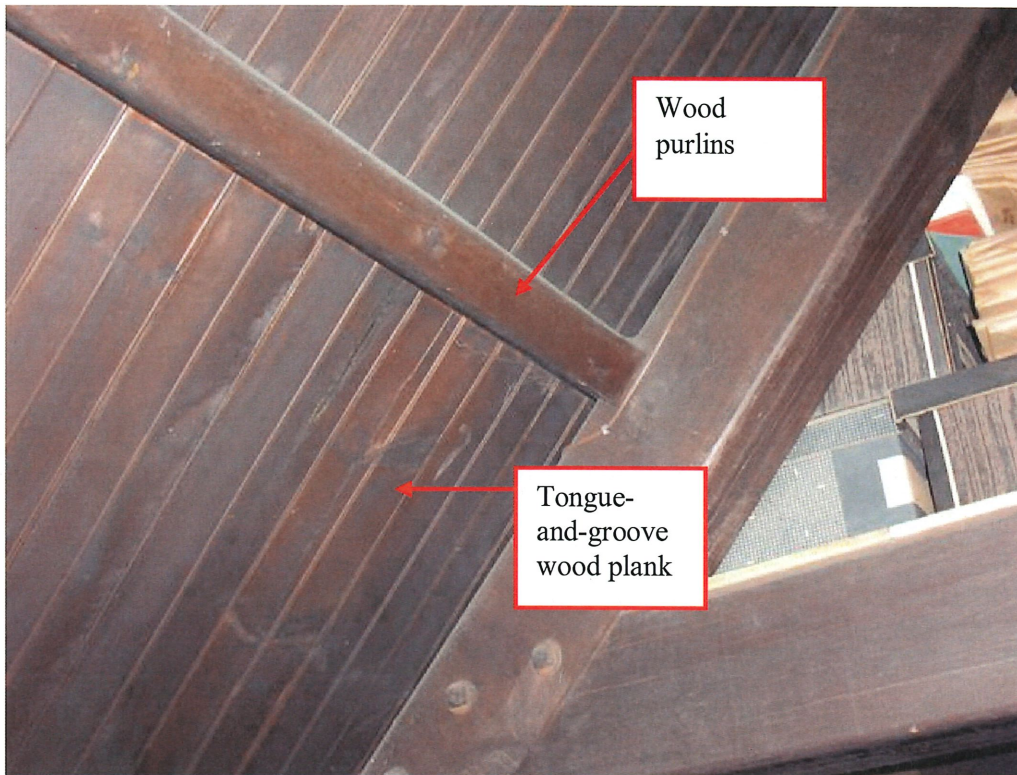
Close-up of timber roof trusses

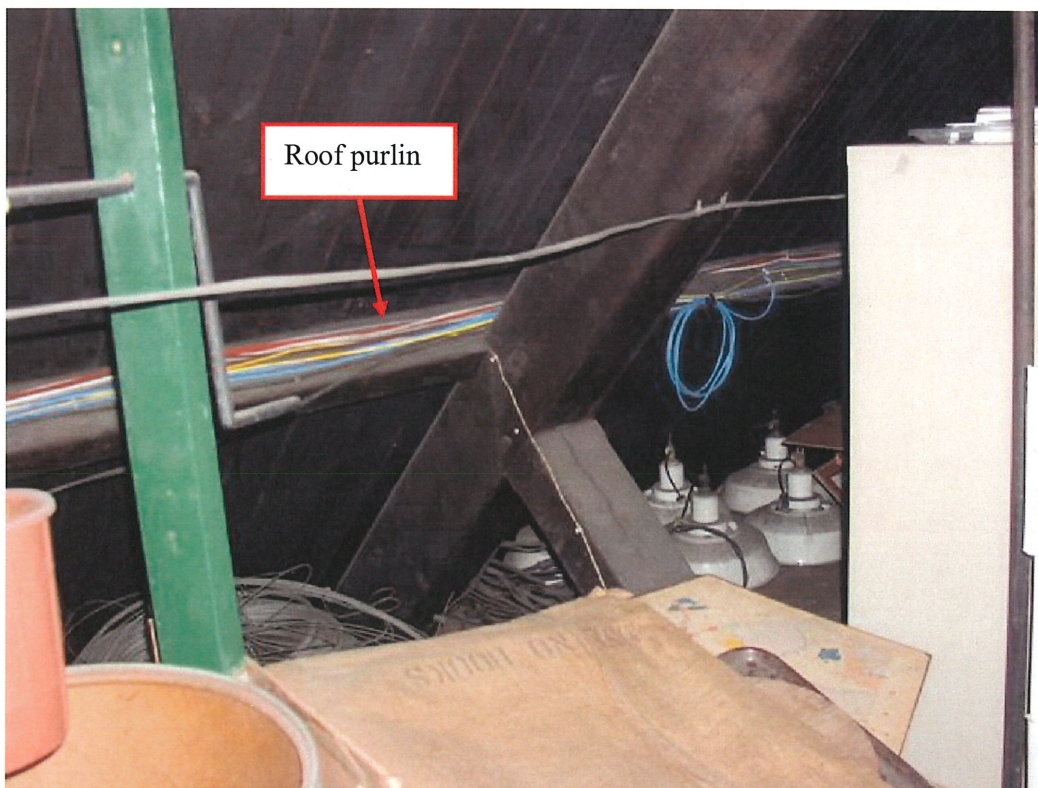
Timber roof truss

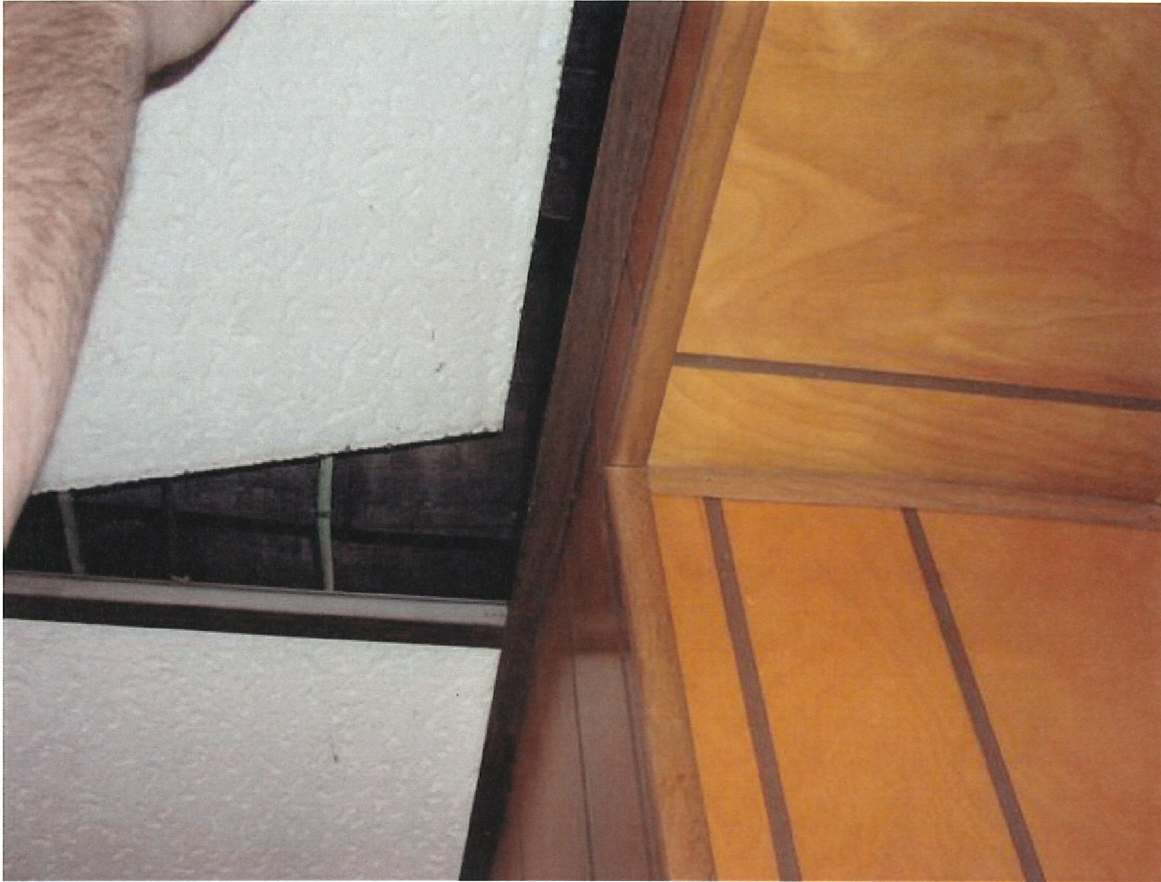
Second floor framing in original building

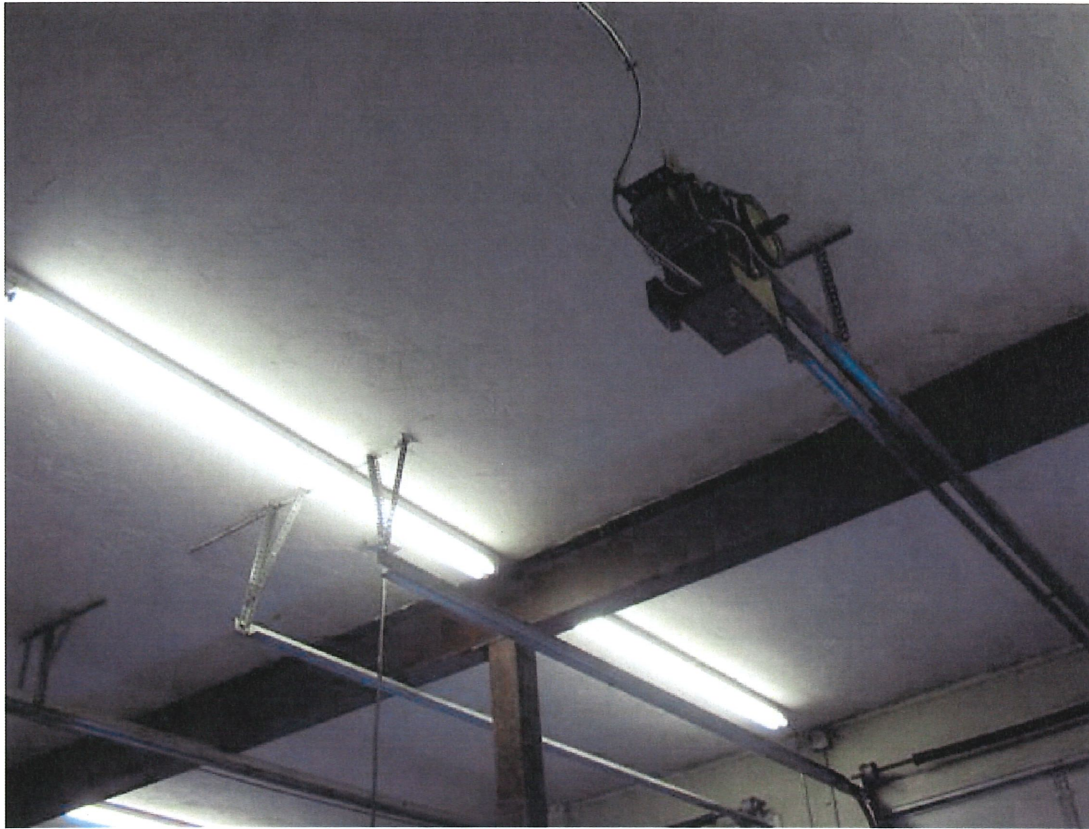
The 1993 addition structure consists of wood roof trusses spanning east to west and bearing on partially reinforced concrete block walls on the west end and steel beams on the east end. The steel beams are supported by steel columns and exterior masonry walls.

Steel framing supporting wood trusses in 1993 addition

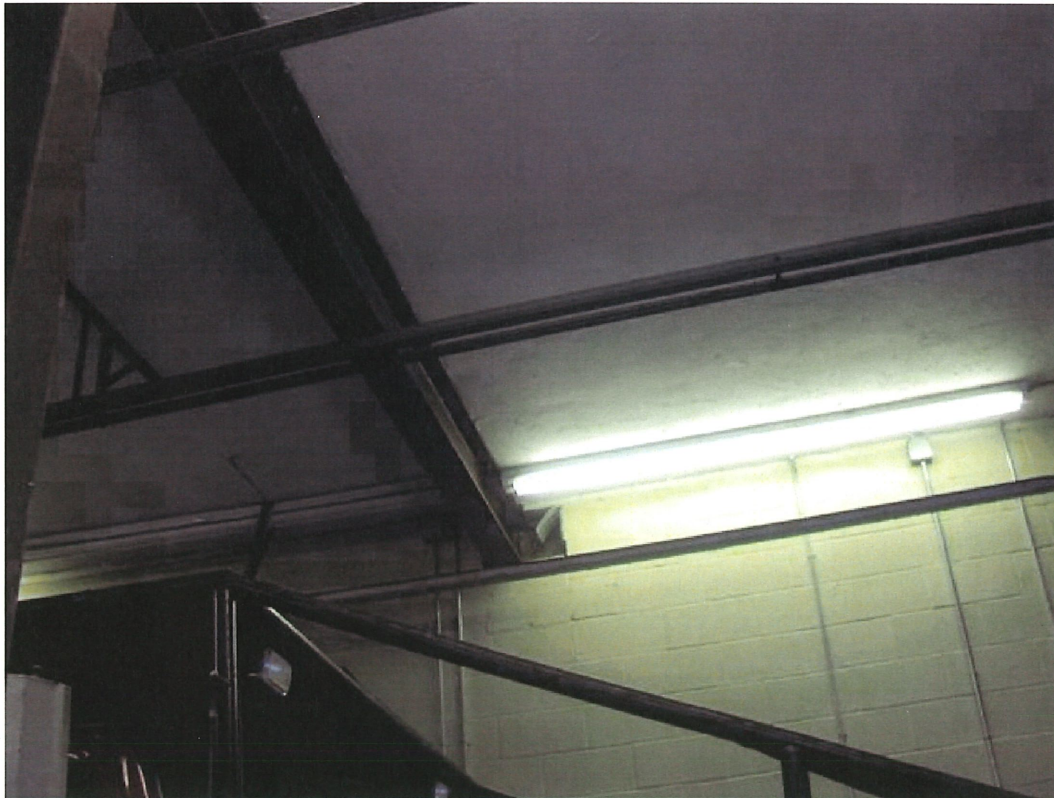
Beam pockets into previous addition masonry bearing wall

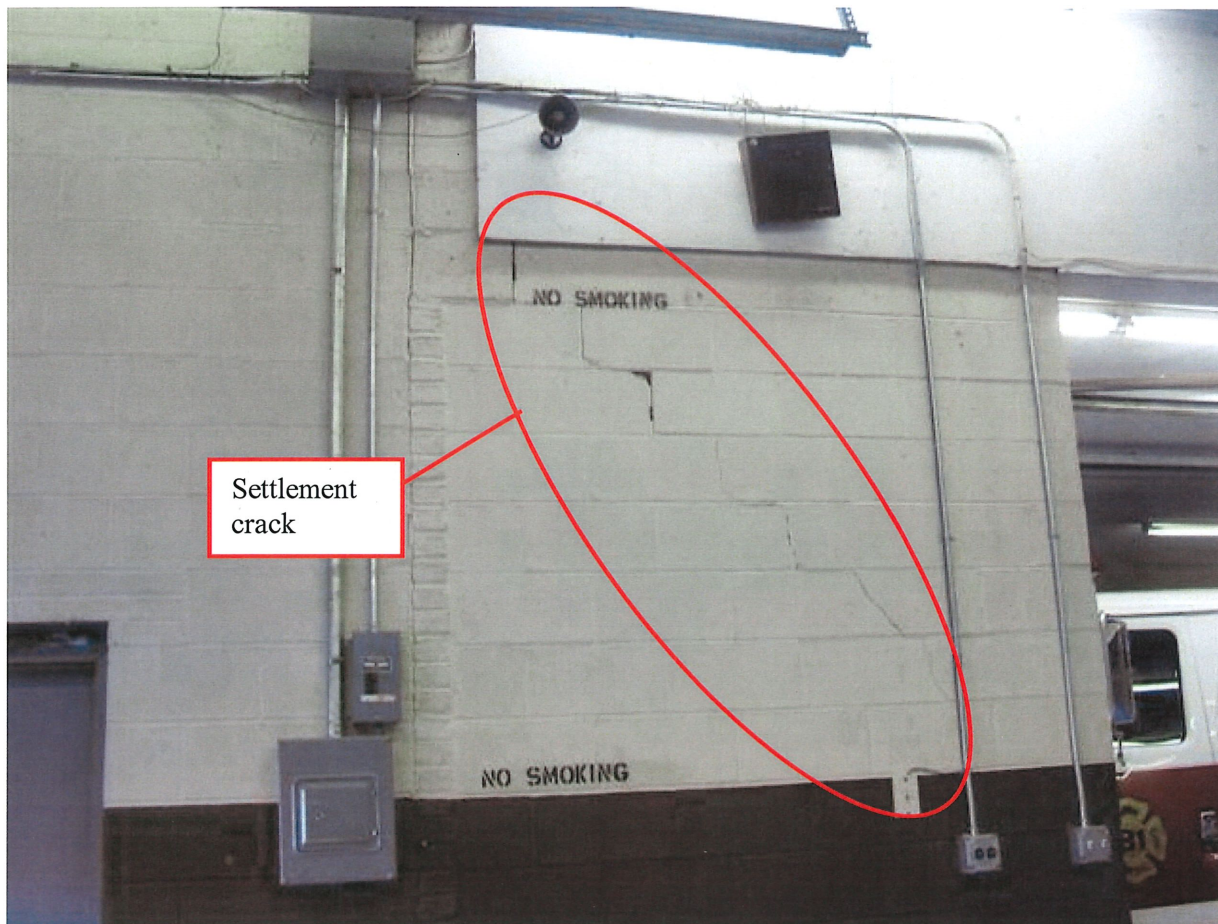
There are issues with the masonry bearing walls of the additions. Settlement or movement was observed in the exposed face of the exterior concrete block bearing walls on the west and south west sides of the pre-1993 additions. Some of the cracks are visible around window and door openings. It is not known if the movement is continuing to occur. Water is entering through the cracks and freeze / thaw damage will aggravate the condition. The foundations in these areas are concealed beneath grade and could not be reviewed for deterioration without excavation.

Former exterior bearing wall

We are recommending that the cracks be further investigated to determine if they are continuing to move and if the foundation has also moved. Crack monitors should be installed over the cracks and KBA would visit the site monthly for a time to take readings of any movement that has occurred.
